**Flood Control Project Maintenance
Levee Inspections**

Fall 2008 Levee Maintenance Deficiency Summary Report

Solano County Public Works (Mellin Levee)

Waterway			Bank	Unit Miles
Unit No. 01 Mellin Levee			Right	0.59

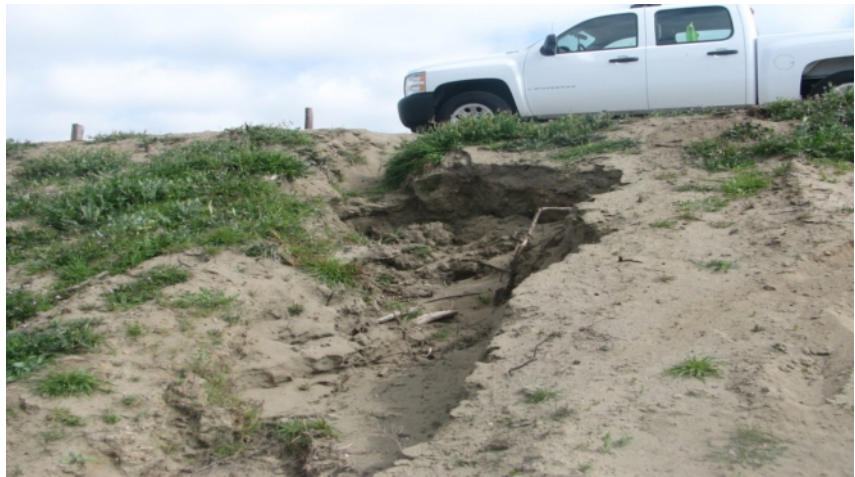
6	0.28	0.32	Earthen Levee	Crown Surface / Depressions / Rutting	CR	M	Add appropriate gravel or road base. Grade and compact.	38.178960 ° -121.680600 °	38.179452 ° -121.681182 °		8
7	0.30	0.30	Earthen Levee	Slope Stability	LS	M	Repair slope instability. Inspector Comments: Slope damage is due to run-off onto uncompacted soil.	38.177107 ° -121.678162 °	38.177107 ° -121.678162 °	Y	6
8	0.48	0.48	Earthen Levee	Encroachments	WS	M	Tree or limb	38.178960 ° -121.680600 °	38.178960 ° -121.680600 °		7

Levee Mile Report Line	7
Start Levee Mile	0.30
End Levee Mile	0.30
Location	
Category	Earthen Levee
Item	Slope Stability
Erosion on landward slope at LM ??
